Connecticut Embayments Study

Department of Environmental Protection
State of Connecticut

Phase I Inventory & Problems Analysis

PHASE I - INVENTORY AND PROBLEMS ANALYSIS

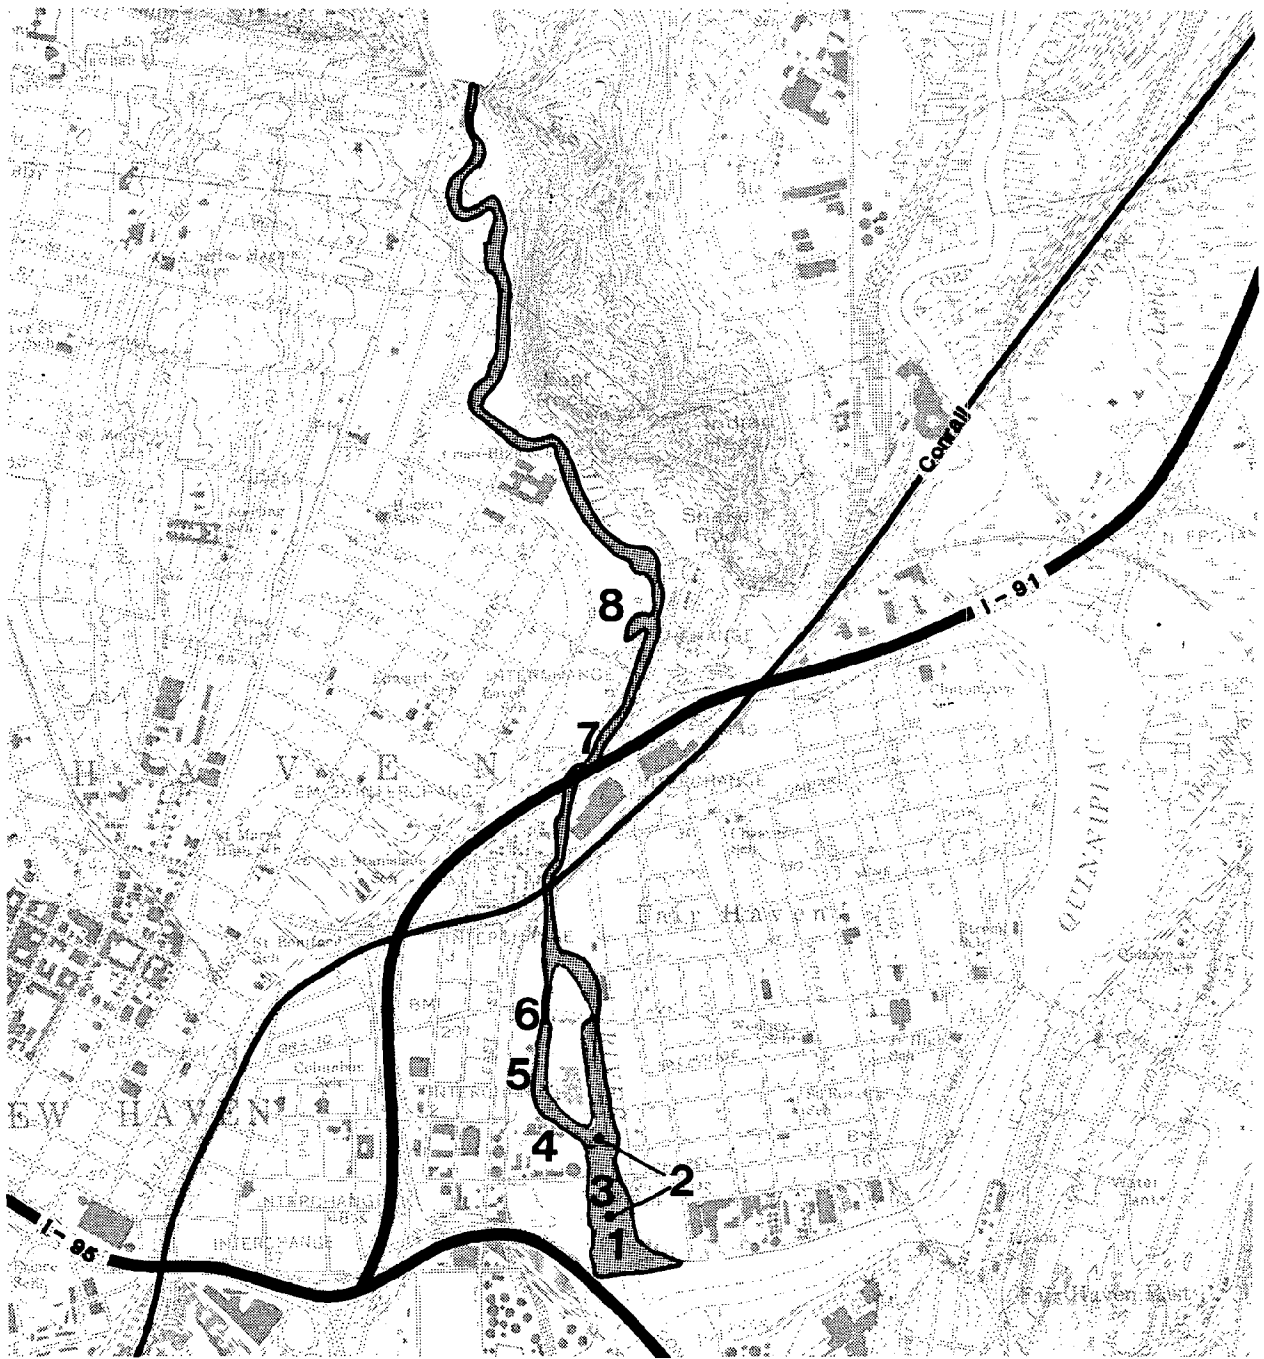
Many of the bulkheads along the lower reaches of the river are old, and in some cases rotting out or completely disintegrated. The sediment banks behind the decayed stabilization are vulnerable to erosion, particularly during high flow periods.

The field investigation confirmed the polluted and severely silted condition of the Mill River below the Grand Avenue Bridge. Close observation from the river bank revealed that the water body is actually effervescent. Anaerobic bottom sediments continually release hydrogen sulfide gas which bubbles to the surface. Extensive sediment gas production also makes the bottom soft and buoyant. Occasionally, glutinous gray chunks of the material float to the surface.

1. Area closed to shellfishing
2. Anoxic bottom conditions
3. Highly contaminated bottom sediment
4. Stormwater runoff from industrial lots
5. Decaying bulkheads
6. Bridge constricts tidal flow
7. Tidegates
8. Filled in floodplain

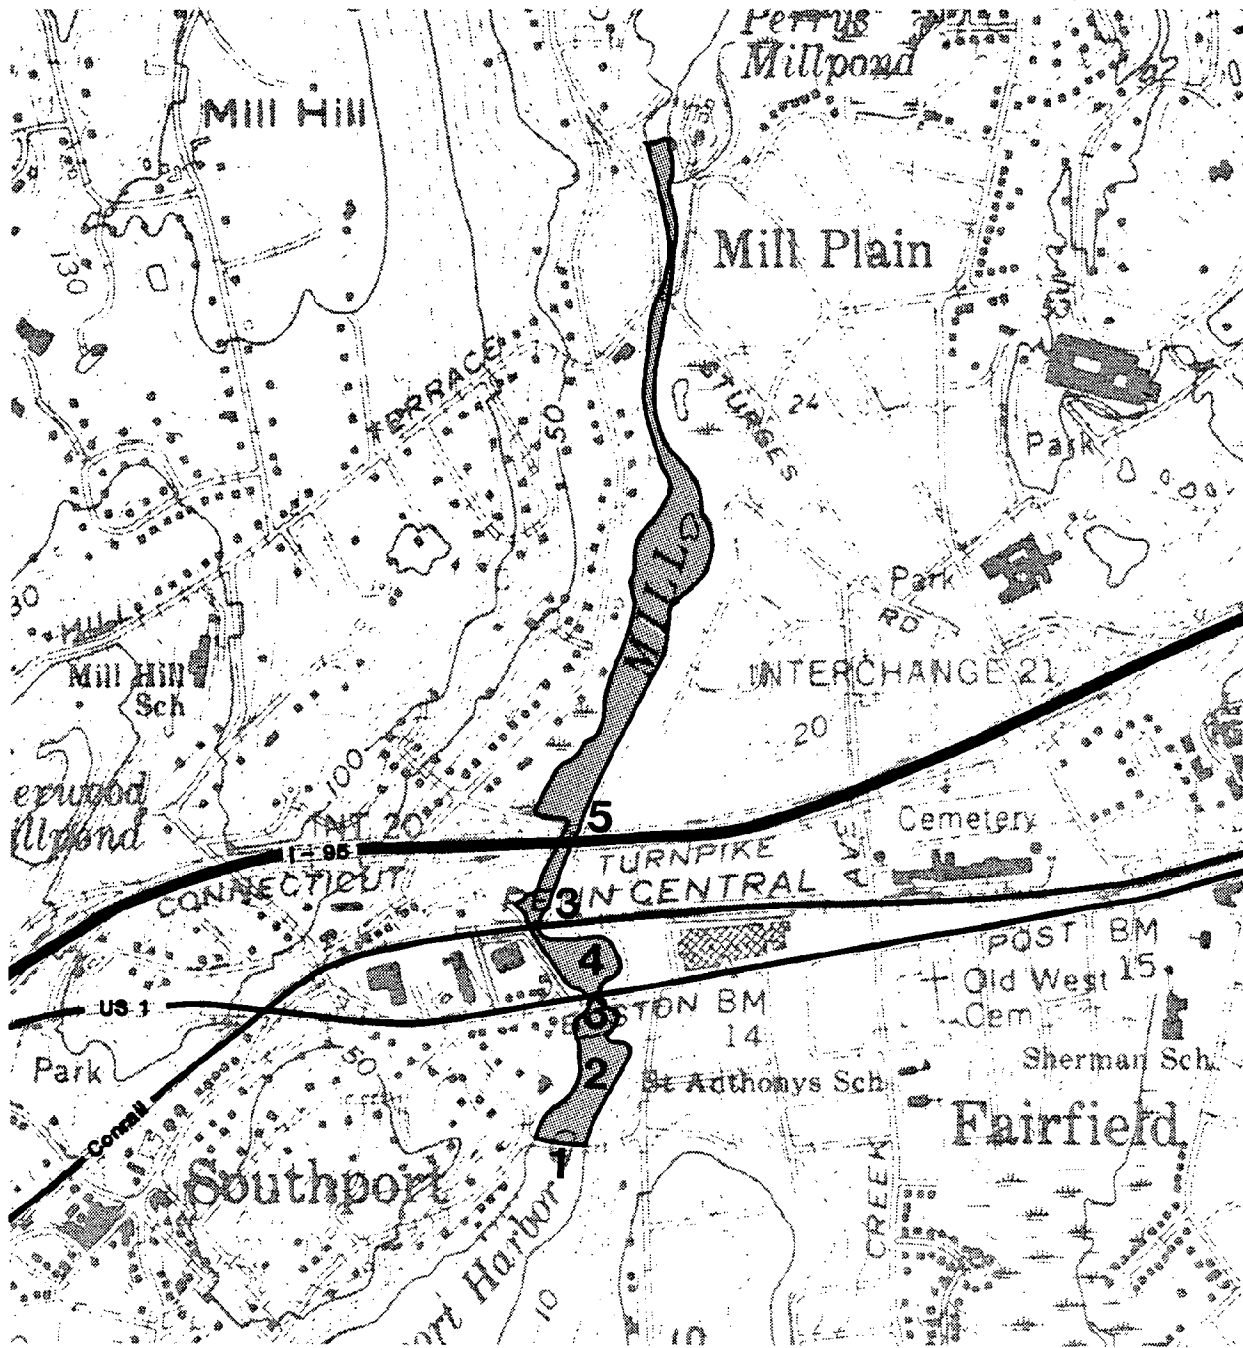
FIG 16.4 MILL RIVER/POND ENVIRONMENTAL PROBLEMS

Though no visible signs of lead contamination were present at the time of the site visit, the location of the ESB outfall pipe was confirmed (See Figure 16.4). Signs prohibiting clamming, crabbing and swimming were also noted in the vicinity. Water sampling on the Mill River since 1977 has documented the lead contamination from ESB wastes. The results of the sampling are summarized in the discussion in Subsection D-2 below. Pollutants in the ESB waste stream (in addition to lead) include oils, acids, and iron.

Tidal exchange on the Mill River is restricted above the Mill Pond dam and spillway at Harbor Road (See Figure 16.4). The spillway creates approximately a four to five foot rise in the riverbed elevation, and thus prevents most normal tides from penetrating further up the river on an incoming tide.
